DEPARTMENT OF TRANSPORTATION**DIVISION OF ENGINEERING SERVICES**

Contract #: 04-0120F4Cty: SF/ALA Rte: 80 PM: 13.2/13.9File #: 69.28**WELDING INSPECTION REPORT****Resident Engineer:**Pursell, Gary**Address:** 333 Burma Road**City:** Oakland, CA 94607**Report No:** WIR-012349**Date Inspected:** 01-Mar-2010**Project Name:** SAS Superstructure**OSM Arrival Time:** 645**Prime Contractor:** American Bridge/Fluor Enterprises, a JV**OSM Departure Time:** 1845**Contractor:** Zhenhua Port Machinery Company, Ltd (ZPMC), Changxing Island **Location:** Shanghai, China

Segment-10AE

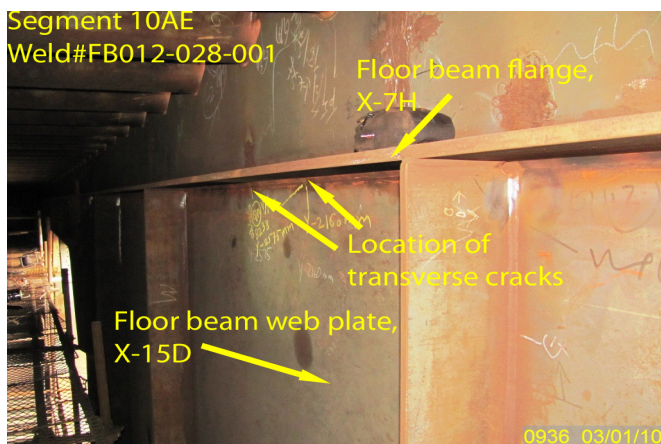
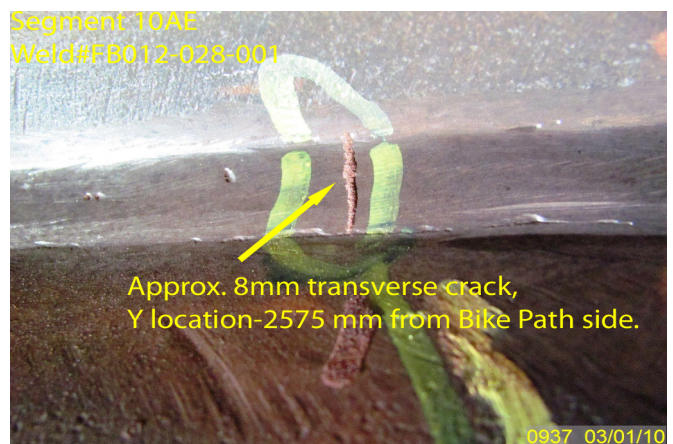
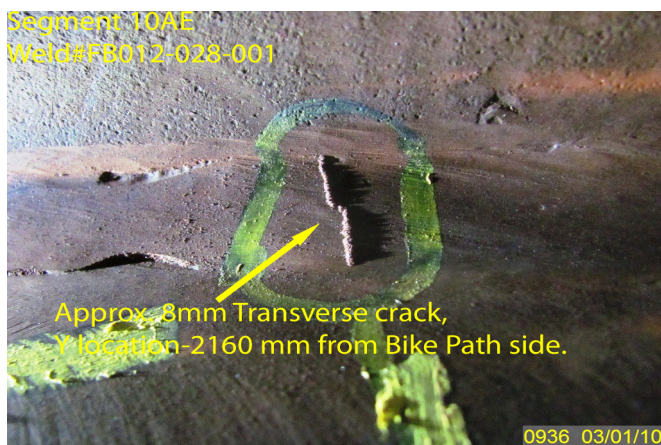
-Two (2) linear indications measuring approximately 8 mm in length.

1. FB012-028-001, Transverse crack, approximately 8 mm in length@ PP88, Y location-2160 mm from Bike Path side.

2. FB012-028-001, Transverse crack, approximately 8 mm in length@ PP88, Y location-2575 mm from Bike Path side.

-These welds are Fillet weld joining the Floor beam Web to Flange.

- The indications were discovered visually and confirmed by Magnetic particle Testing (MT) by Caltrans QA.
